Beckfoot Phoenix School - Accessibility Action Plan.

Updated: 10/01/2025

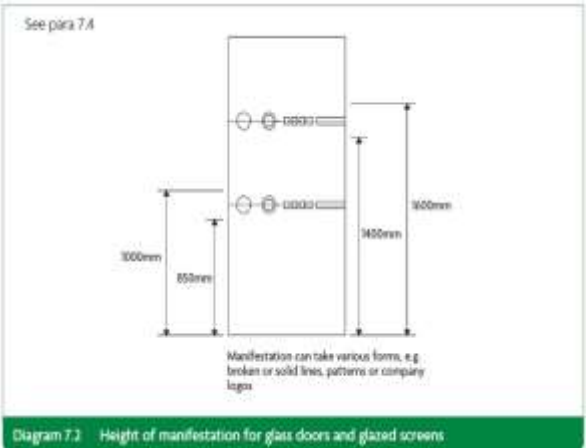
Item Ref.	Details / Issue	Recommendation	Est Cost	Action Taken
5.9	Manifestations are not provided and are required for the main entrance.	<p>Well contrasted manifestations should be provided at two heights to the entrance.</p> <p>Glazed doors need to have permanent strips on the glass within two zones, from 850mm to 1000mm from the floor and from 1400mm to 1600mm from the floor. These strips need to be contrast in colour (not treated glass) and luminance with the background seen through the glass in all light conditions.</p>

M	To be installed Feb half term

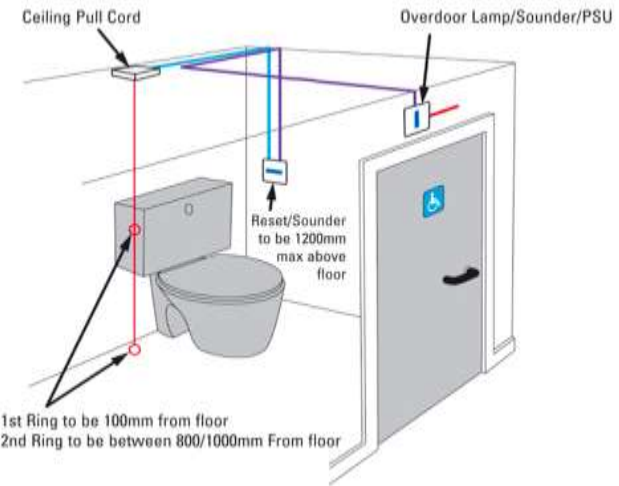
13.11	<p>On the day of the survey, the cord alarm within most of the accessible WC was not hanging loose hence should someone stumble on the floor they would not be able to reach it.</p> <p>WC 6 WC 39 WC 77 WC 96 WC 121 WC 43</p> <p>Cords in wet rooms and within changing areas for hydrotherapy pools</p>

<p>Cord alarms should be provided, and monitored to ensure that they function correctly and are located at full length in their correct position so that they can be accessed in the event of an emergency.</p> <p>Emergency alarm cords should always feature bangles at two heights and stand at 100mm off the ground floor level. According to BS8300 an emergency assistance pull cord should be sited so that it can be operated from the WC and from an adjacent floor area. The emergency assistance pull cord, coloured red, should be provided with two red bangles of 50 mm diameter, one set at a height between 800 mm and 1000 mm and the other set at 100 mm above floor level.</p> <p>BS8300 recommends that the reset control for the emergency assistance alarm should be clearly marked as such and should be reachable from a wheelchair and, where relevant, from the WC. The reset control should be easy to operate and located with its bottom edge between 800 mm and 1 000 mm above finished floor level. The marking of the reset control should be both visual and tactile.</p>	N	Have all been checked and any defects rectified.

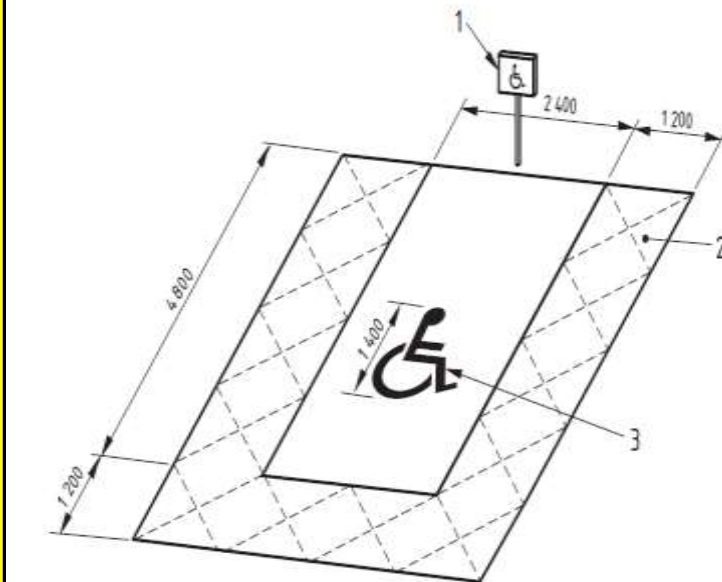
2.3 (cont)

2.3	<p>The first 5 designated accessible parking should be clearly marked out at least 2.4m wide x 4.8m long plus a 1.2m side transfer zone at the side and end of the bay.</p>	<p>The accessible bay markings should provide clearly defined 1200mm transfer zones to both sides and rear and with the required access symbol.</p> <p>BS8300 recommends a sign or, if appropriate, signs should be provided at the entrance to each car park and at each change in direction to direct disabled motorists to designated parking spaces. Also, install a sign to the front of each space as shown:</p>	M

- 1 Sign, with its lower edge 1 000 mm above the ground, to identify parking space when road markings obscured e.g. by snow or fallen leaves, with the words "Blue badge holders only"
- 2 1 200 mm wide access zone between designated parking spaces
- 3 International Symbol for Access

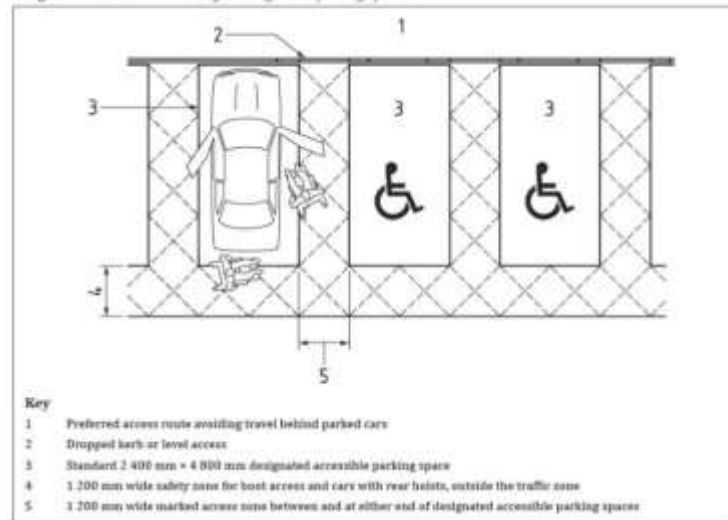
Figure 4 — Access around designated off street parking spaces

- 1 Preferred access route avoiding travel behind parked cars
- 2 Dropped kerb or level access
- 3 Standard 2 400 mm x 4 800 mm designated accessible parking space
- 4 1 200 mm wide safety zone for foot access and cars with rear belts, outside the traffic zone
- 5 1 200 mm wide marked access zone between and at either end of designated accessible parking spaces

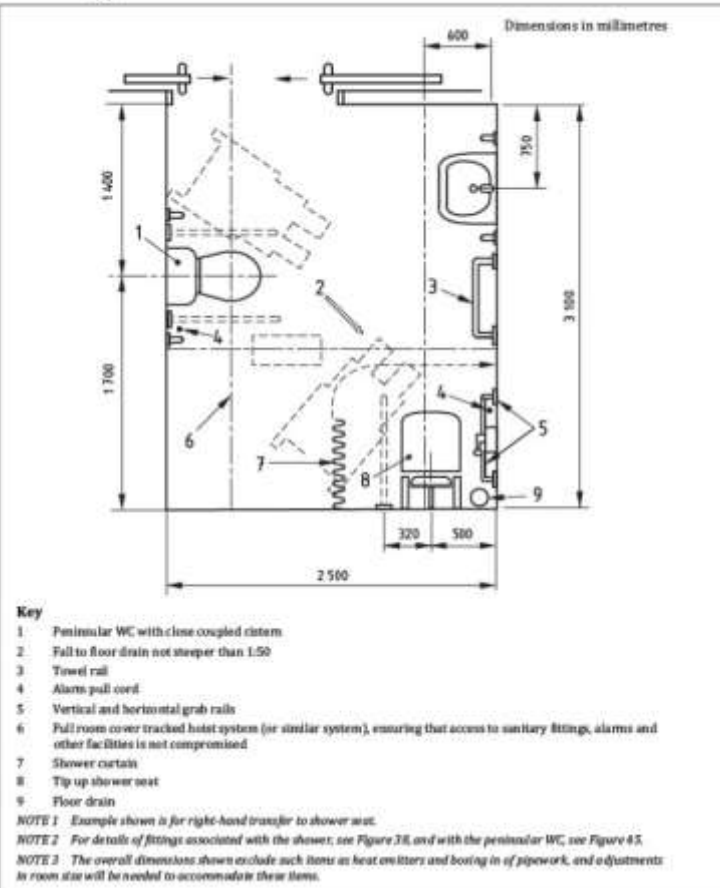
Figure 31 — En-suite shower room for use with a ceiling-mounted full room cover tracked hoist system for assisted use

12.8	<p>Various accessible changing rooms were provided and with all having ceiling mounted hoists and some with changing beds. All had peninsular style WCs.</p> <p>Most had tip up shower seats with drop down rails to either side but none had vertical wall mounted rails. None of the sinks had wall mounted grab-rails.</p> <p>Two showers with stepped access and no grab rails were seen but as there is range of accessible facilities this would be deemed suitable to retain - but for future development consider showers with level access and grab-rails for the shower.</p> <p>Grab rails and WC seats contrasted but the sinks and WC pan did not contrast.</p> <p>A mixture of flushes were seen.</p> <p>All had lever taps for showers and sinks.</p> <p>Alarm cords for most were tied up or cut off.</p> <p>Changing areas for hydro pool - 38, 39 mirror of each other, cords tied up.</p> <p>Showers by hydro pool - 31, 32, same</p> <p>Shower and WC 56, 57, same</p> <p>Wet room/ shower 76 no sign on door cord cut</p> <p>Wet room/ shower with hoist 94 not used as shower.</p> <p>Wet room/ shower with hoist 122 (123 mirror image)</p> <p>Wet room/ shower & WC with hoist 132</p>	<p>Colour contrast should be added to the fixtures and fittings within the showers, or the walls should contrast from the fittings.</p> <p>According to BS8300 - to help blind and partially sighted people identify key objects within sanitary accommodation, support rails and grab rails should contrast visually with the wall, the WC seat and cover should contrast visually with the WC pan and cistern, and sanitary fittings and accessories should contrast visually with the background against which they are seen.</p> <p>Refer to BS8300 recommendations regarding the locations of grab rails and other fittings, as appropriate, for peninsular style WC and bathroom facilities.</p> <p>Refer to recommendation for 13.11 regarding cord alarms.</p>	M/OG

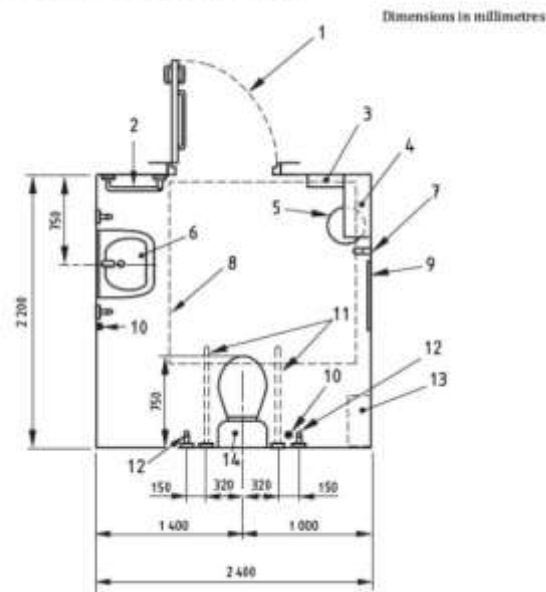
Figure 45 — Unisex accessible toilet with penicular WC for assisted use

| 1 This door may be in any position along the wall but the leading edge should be not less than 300 mm from a return wall | 8 Wheelchair turning space (1 500 × 1 500) mm |
| 2 Towel rail | 9 Independent tall mirror |
| 3 Sanitary dispenser | 10 Alarm pull cord |
| 4 Shelf | 11 Drop-down support rails, one with a toilet paper dispenser |
| 5 Disposal bin | 12 Vertical grab rail |
| 6 Large washbasin with vertical grab rails either side and mirror over (see Figure 43) | 13 Sanitary disposal unit |
| 7 Two clothes hooks, one at 1 050 mm and the other at 1 400 mm above the floor | 14 Flat-topped close-coupled cistern providing a back rest and a colostomy bag changing surface for standing users ⁴⁾ |

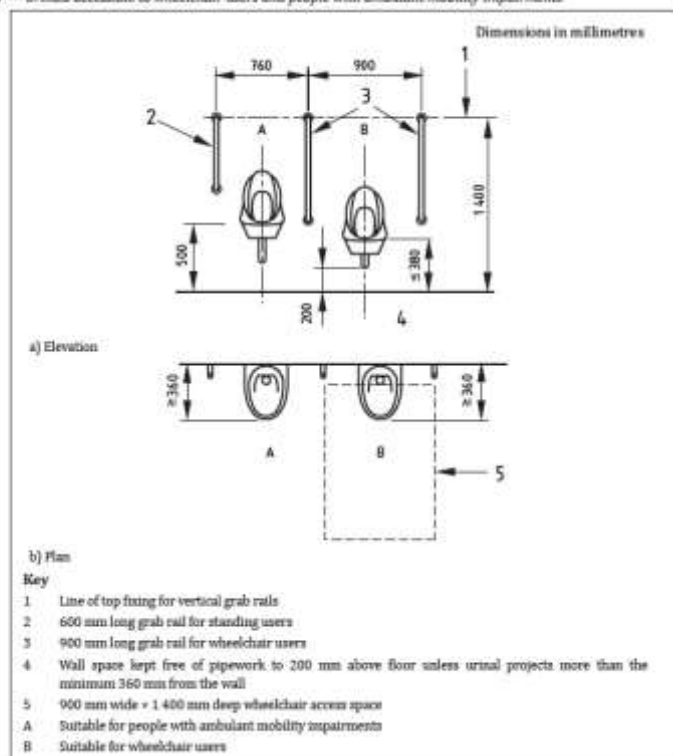
Figure 47 — Urinals accessible to wheelchair users and people with ambulant mobility impairments

12.5	Urinals in the boys WCs contrast but do not feature grab rails to aid ambulant disabled persons.	<p>It is suggested that urinals for wheelchair users and ambulant disabled people are provided as well. The wheelchair space in front of a urinal should be level. Vertical grab rails for the benefit of a disabled person who is standing should be provided on each side of a urinal where stall privacy dividers are not fitted.</p> <p>Fittings, support rails and grab rails should contrast visually with the wall; the WC seat and cover should contrast visually with the WC pan and cistern; and sanitary fittings and accessories should contrast visually with the background against which they are seen.</p> <p>See below for suggested layout.</p>	M	
------	--	---	---	--

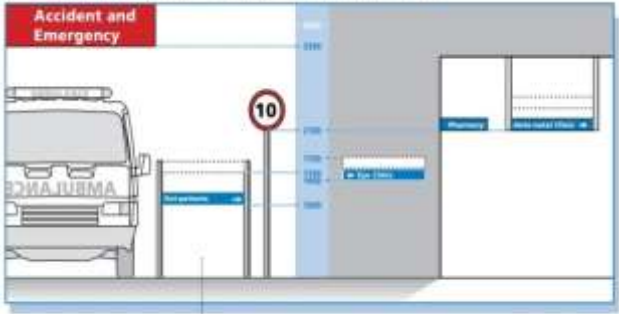
<p>15.2</p>	<p>Upon entering the reception area there is a lack of suitable directory signage.</p> <p><small>This diagram gives general guidance on the suggested height for positioning different types of sign, determined by the intended use of the sign (all dimensions are given in millimetres)</small></p>

<p><small>NOTE: Position external signs that are likely to be obscured by passing or parked vehicles at least 1500 mm from the ground. Signs that are located away from possible obstructions can be positioned lower.</small></p>	<p>Signs and universally accepted symbols or pictograms, indicating lifting appliances, stairs, toilets, circulation routes and other parts of the building, should be provided in the reception area. The NHS Wayfinding guide and Exhibitions for All (NMS) offers good guidance regarding positioning.</p> <p>Consistency of sign height and position throughout the premises is important. Signs should be placed between 1400mm and 1700mm for blind and partially sighted people when standing. For wheelchair users signs should be placed between 1000mm and 1100mm above floor level. Signs associated with control panels, e.g. lifts or door entry systems should be located between 900mm x 1200mm, to meet the needs of both wheelchair users and people standing.</p> <p>The RNIB and the Joint Mobility Unit recommend positioning all signs at eye level (1500 mm), including tactile (embossed) and Braille signs. If posts are used for fixing signs, or signs are free-standing, they must contrast with the environment so they are visible for people with visual impairment.</p>	<p>M/OG</p>

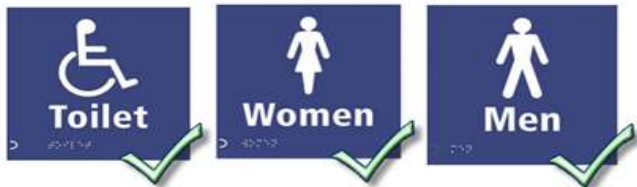
15.3	<p>WC doors had signage provided on most but the accessible shower/ changing facilities did not have signage.</p> <p>Lobby doors did not always have signage on them - and most lobbies led to 4 or 5 WCs/ WC areas.</p> <p>There is a lack of signage to indicate where the toilets are located, there is no tactile or Braille signage provided on the toilet doors.</p>	<p>The appropriate toilet signage should be provided as part of the recommended way finding review, refer to 15.1. As well as signage on the toilet doors, there should also be signs indicating where the accessible WC is located.</p> <p>BS8300 states - Information and direction signs should be provided at each point where they are required, e.g. at junctions of circulation routes, at key locations such as doorways and reception points, at facilities such as telephones and toilets, and in rooms, spaces and counters. The colour, design and typeface of signs should be consistent throughout a building.</p> <div data-bbox="958 647 1592 834">

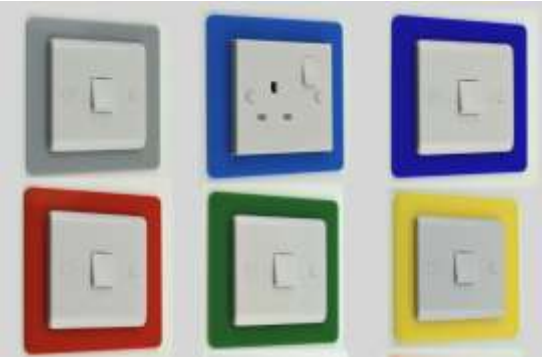
16.2	<p>The majority of the light switch plates seen are not suitably colour contrasted against their background.</p> <p>Lighting in most areas appeared to be automatic with a few manual switches seen.</p>

<p>At the next refurbishment for the sites, it would be beneficial to change the existing light switch plates with alternatives that have a grey/silver plate.</p> <p>Alternatively, light switch plates with a contrasting surround could be used.</p> <p>This will ensure that they are easily located by people with impaired vision.</p>	M	
------	--	--	---	--

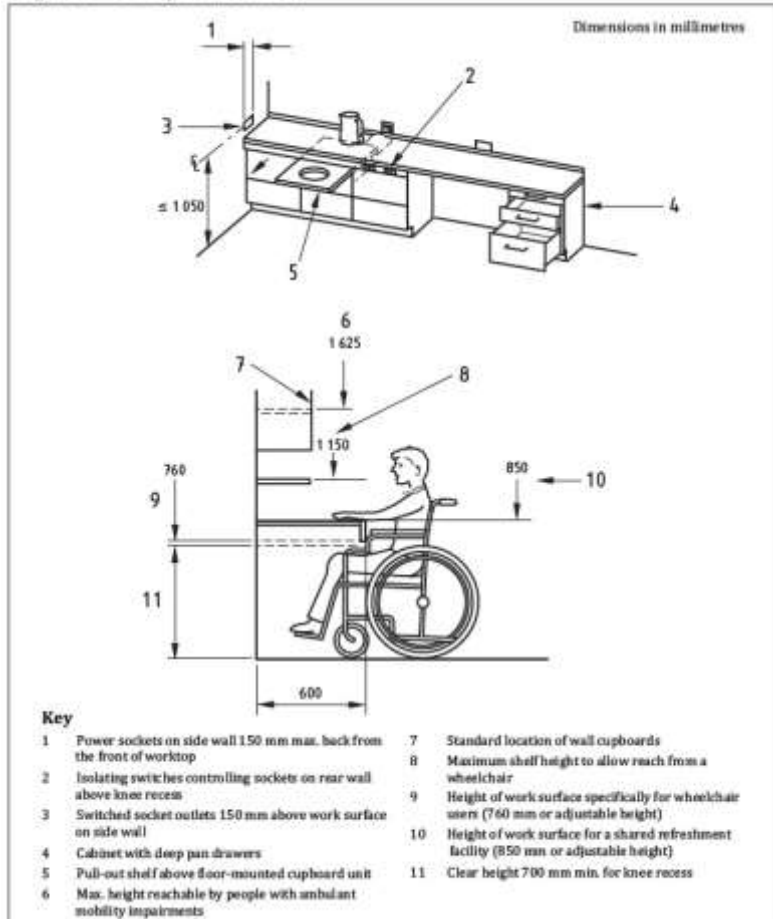
Figure 50 — Work surfaces and accessories

14.8	<p>A range of taps were seen and some were lever style taps. Others were turn taps.</p> <p>Classrooms had sinks with taps but not lowered counters.</p> <p>Room 86 teaching kitchen, 131 nursery kitchen have height adjustable hobs.</p> <p>Nursery has height adjustable sink in main area.</p> <p>Parents meeting room had a lower counter but not a specific style intended for use by a wheelchair user.</p>	<p>A kitchen area should have an unobstructed floor space of at least 1 500 mm × 1 500 mm between facing floor units or between floor units and a wall. Where possible, an unobstructed space or knee recess, at least 800 mm wide, should be provided to one side of kitchen appliances such as refrigerators, washing machines, freezers or ovens.</p> <p>Taps should be changed to lever style or automatic sensor taps to aid people with limited dexterity.</p> <p>The kitchenettes should include disability access, i.e., a section of work top lowered to 760mm (or 850 for a shared worksurface) with clear space underneath of minimum 700mm to allow wheelchair access; sink unit to have lever taps fitted, and utensils included.</p> <p>Refer to images.</p>	M/ST
